Sample Inspection with IR SCAN SMITH

123 MAIN STREET
CALGARY AB

23/02/2016

Golumbia Solar Structures Ltd. o/a HouseMaster

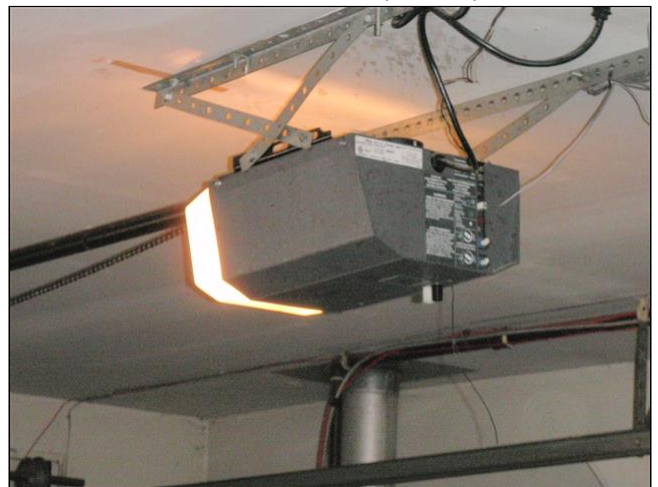
4.10 DOOR OPERATOR(S) Item 1(Picture)

LEFT DOOR did not reverse at obstruction. Consult owner's manual or have checked by a qualified technician. CORRECT ASAP... EXCESS SLACK IN DRIVE CHAIN.
●	●				4.11 ELECTRIC / GFCI SURFACE WIRING TO BE CORRECTED.. ADD PROTECTION/CHANGE WIRE TYPE/REMOVE AS NEEDED.. HAVE CORRECTED BY AN ELECTRICIAN.
●					4.12 DOOR TO HOUSE Garage / house door has no automatic closer installed. Add for safety....CLOSER WAS NOT REQUIRED AT ORIGINAL CONSTRUCTION.
			●		4.13 UNIT HEATER/FURNACE UNIT WAS NOT LIT.... APPEARS TO BE AT ROUGHLY 20 YEARS OLD.... DUE TO AGE AND SELLERS STATEMENT THAT IT IS BEING SOLD AS IS, I SUGGEST YOU BUDGET FOR REPLACEMENT WITH AN OVERHEAD "UNIT HEATER" OF HIGHER EFFICIENCY IF POSSIBLE. INSPECTORS WILL NOT ATTEMPT TO LIGHT UNLIT GAS APPLIACES AS WE CANNOT KNOW WHY THEY ARE OFF.
